MASSACHUSETTS HISTORICAL COMMISSION
294 Washington Street, Boston, MA 02108

Brown-Simmons Cemetery

Cemetery Reconnaissance Inspection Checklist

Name of Cemetery: *BROWN SIMMONS (MACRIS SOM. 822)*

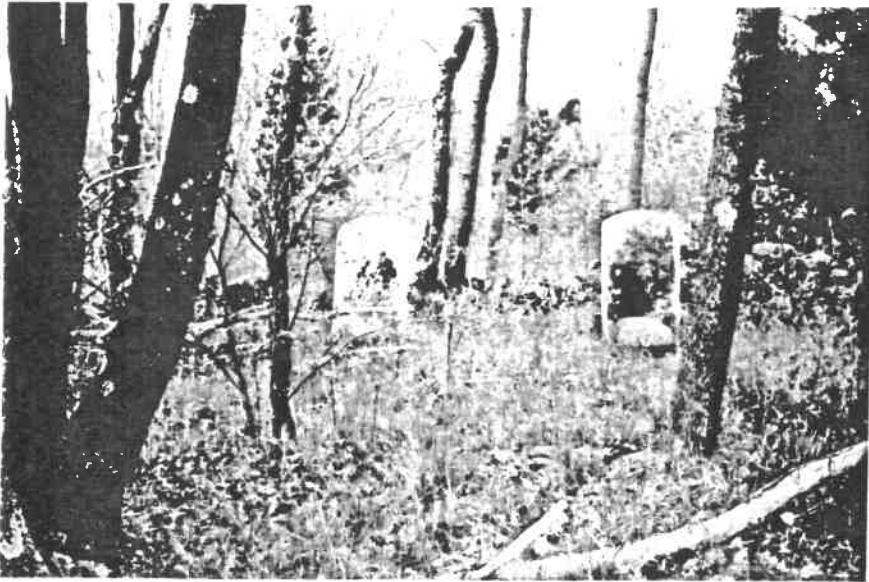
Condition Overgrown with trees, bushes,
and weeds and fallen trees. Two stones

noted above are held erect by boulders
piled around their bases. Stone walls

enclose an area approx. 100 x 100'

but these two are the only stones discernible.

The sole two stones standing are rectangular white sandstone with rounded tops marking graves of Edward Slade and his wife Mary Ann. Base of one bears the carvers name: W.W. Chace. Headstones carry no motifs.

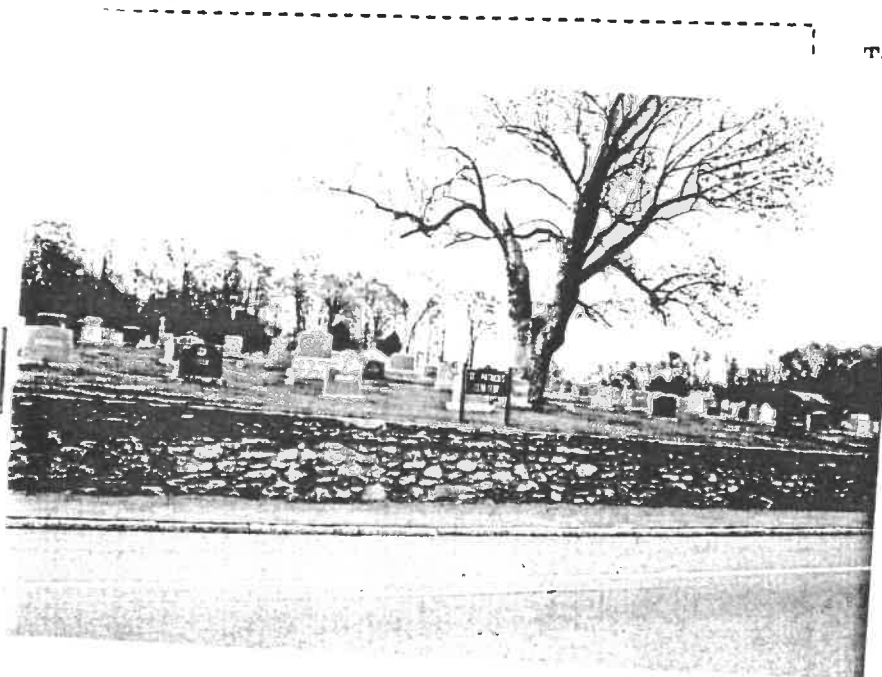
Condition Excellent, grounds

well tended, little vandalism

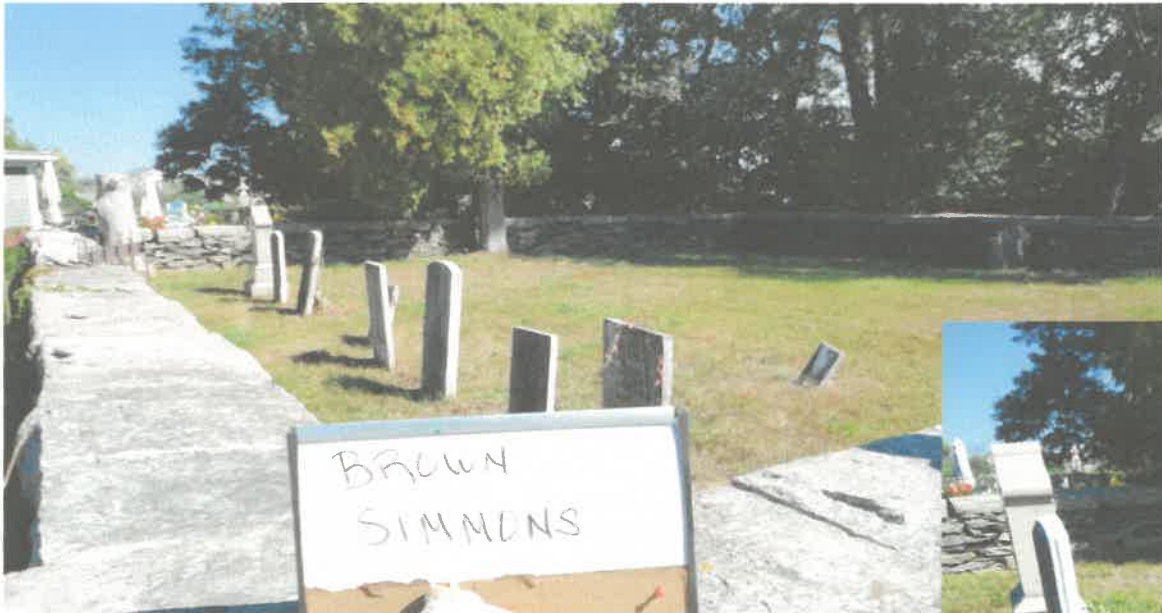
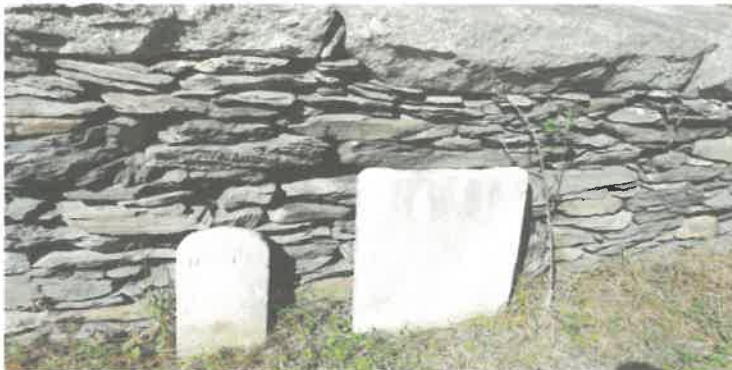
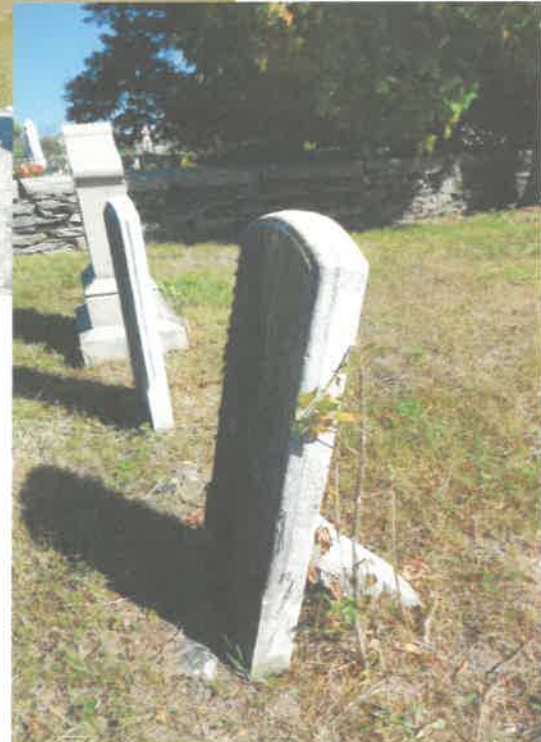
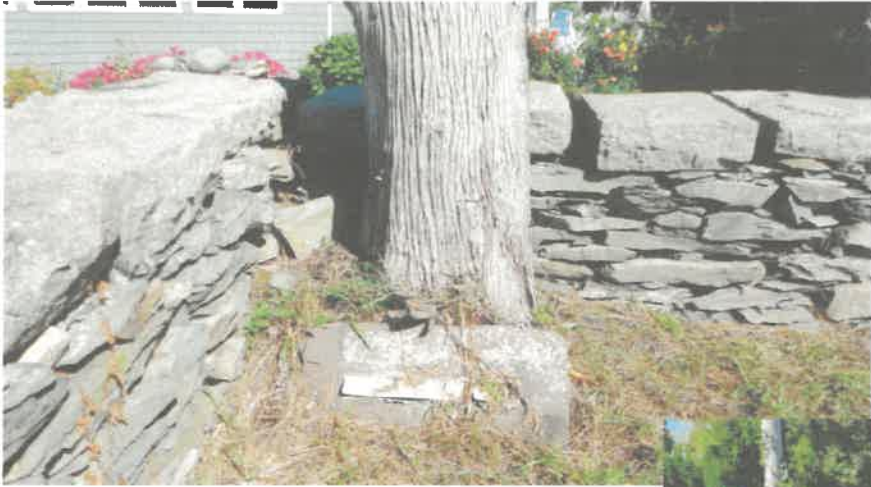
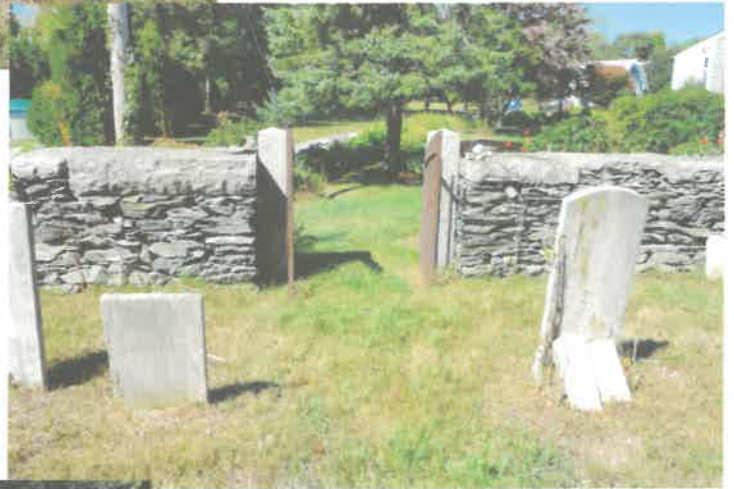
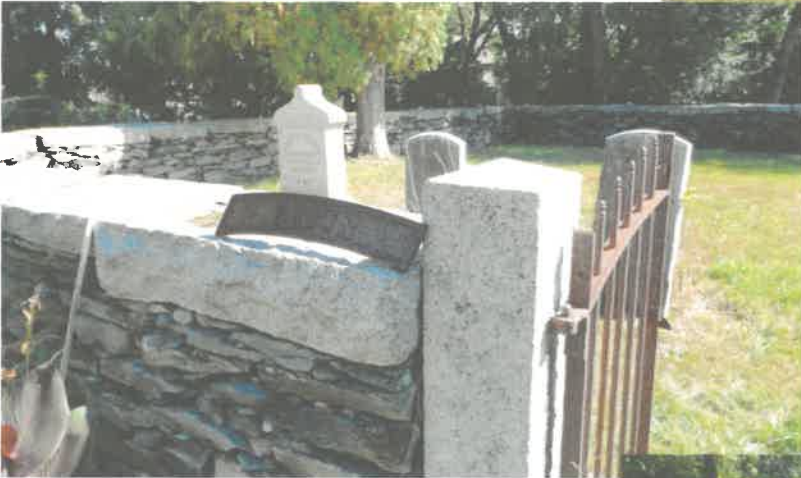
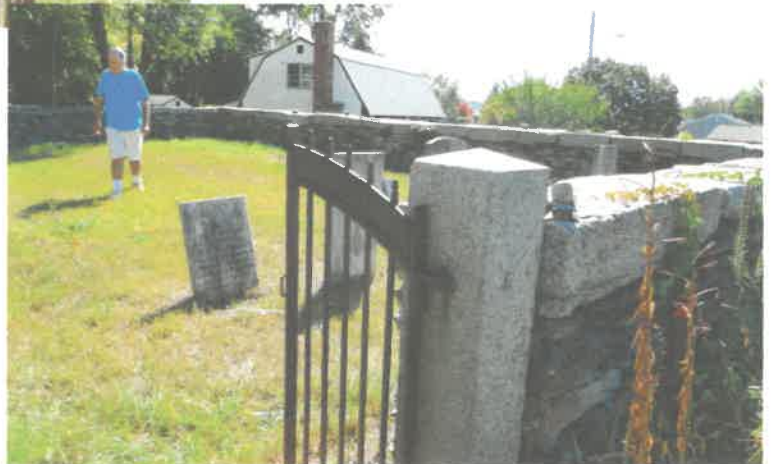
Remington Drive, off Pleasant St, South of Sandy Point Rd. Square plot bounded by field stone walls, the top layer of which is granite slabs 8" thick and 2' wide and varying lengths to 3'. West wall has a small iron gate mounted between two granite pillars 4' high. Located on a small knoll overlooking the Taunton River. Earliest discernible date on a marble headstone is 1817. Brown Simmons died in 1838.

Well groomed, grass cut, gates located on west wall rusted, but hinges working. "Brown" nameplate detached, rusted broken attachments. One row of eight (8) headstones with inscriptions along west wall. Three of the eight stones are broken and in need of repair. One foot stone is in place at the grave of Brown Simmons, and remaining foot stones are being used to prop up one headstone, and one foot stone is against the west field stone wall in the NW corner. Also in the NW corner against a dead tree stump is a broken base with residual marble in the groove. 7 headstones are marble, the large monument is granite. The cemetery appears to have had three other rows of graves filling the cemetery as the soil is slightly sunken in patterns and rows which could be graves. No markers were visible, however. Spoke with neighbor, Scott Erickson (508) 678 2275, who stated the neighbor to the north, Carl, has received permission from the town to care for the cemetery, and he spends a great deal of time cutting the grass and maintaining the site. Neighbors also work on the knoll area and ensuring it does not deteriorate.

Priorities: *Clean stones
 Repair 3 monuments
 Well cared for, neighbors have adopted caring for the site and will continue to do so*

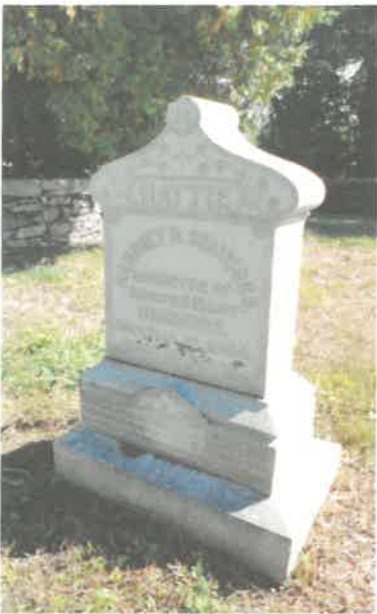
Stone Inscription	Stone Image	Condition Description
<p>“Hattie Harriet B. Simmons Daughter of Brown & Mary Simmons died Mar 15, 1894 aged 39 years”</p> <p>4 line inscription on middle stone, not legible unless cleaned</p>

<p>Large 3 piece monument, ornate, with ivy leaves and vines at cap; some lichen on lower bases and bottom of top piece, legible inscription, straight, great condition</p> <p>Hattie was born in 1855 in Dighton, MA, died in Somerset</p> <p>Daughter of Brown and Mary Hall Simmons</p>
<p>“Brown Simmons died Sept 29, 1865 aged 70 years, 1 months 6 days”</p> <p>ornamental scrollwork</p> <p>6 line inscription</p>

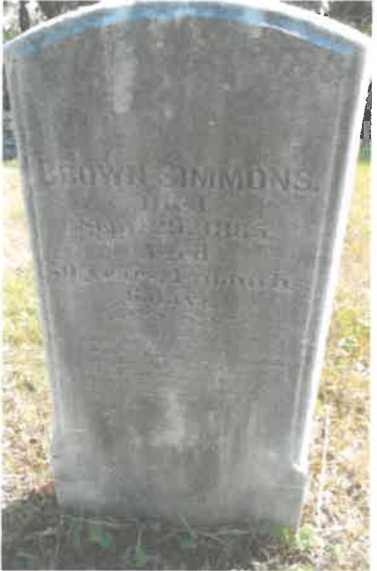
<p>Simple white marble stone, small ornamental carving at end of inscription</p> <p>upright, intact</p> <p>needs cleaning only</p> <p>Brown Simmons was born 1795, son of Brown and Huldah Simmons, died in Dighton, buried in Somerset</p>
<p>“Mary wife of Brown Simmons died July 25, 1886 aged 78 years, 11 months 13 days”</p> <p>4 line inscription</p>

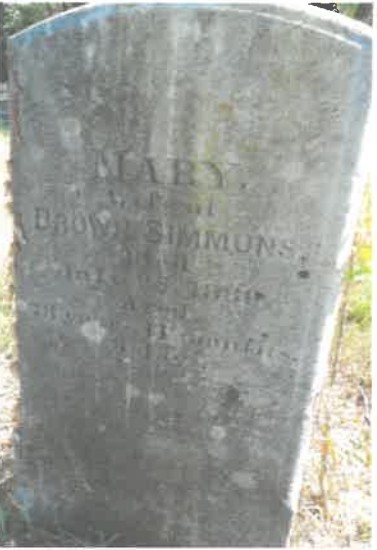
<p>White marble stone, broken at the base</p> <p>Propped up by two footstones, leaning backward, needs repair</p> <p>Would benefit from cleaning</p> <p>Father was Parker Hall Mother was Mary Hall</p> <p>Born 1808 Portsmouth Residence Dighton Died Somerset</p>

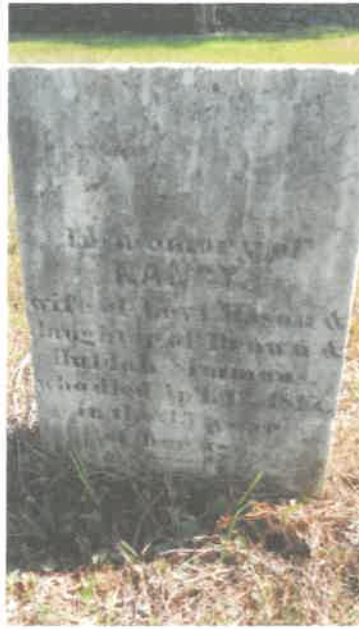
“In memory of
Nancy
wife of Levi Mason
daughter of Brown &
Huldah Simmons
who died Ap'l 12, 1817
in the 65 year
of her age”

White marble stone broken at the
base and re-buried, leaning
backward

Marble would benefit from
cleaning and needs repair

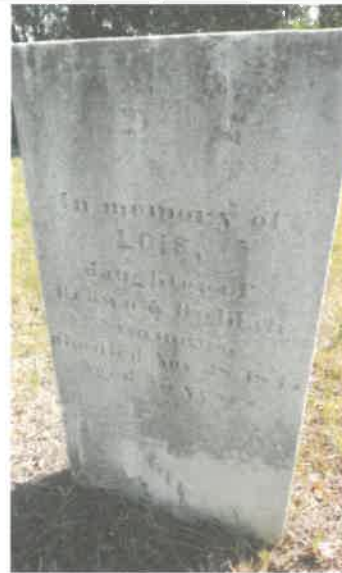
“In memory of
Lois
daughter of
Brown & Huldah
Simmons
who died Nov 28, 18##
aged 55 years”

4 line inscription at base

Good condition, white marble

Leaning forward, but stable

Would benefit from cleaning

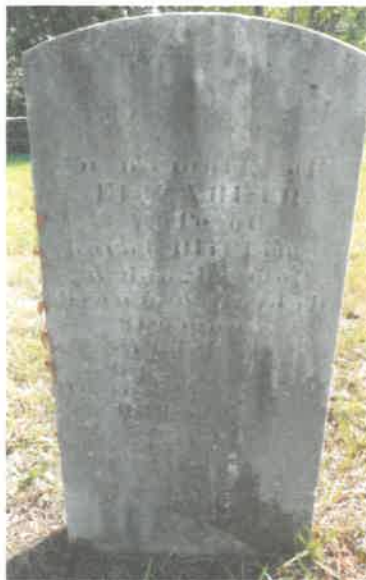
“In memory of
Elizabeth
wife of
Royal Bliffins
& daughter of
Brown & Huldah
Simmons”

4 line inscription

White marble, would benefit
from cleaning, minimal tilt, but
intact

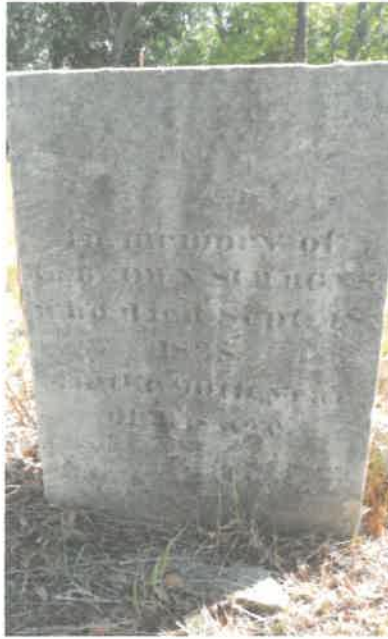
Close up of
Brown Simmons
see below
image
w/ foot Stone

“In memory of
Mr. Brown Simmons
who died Sept 18
1838
in the 90th year
of his age”

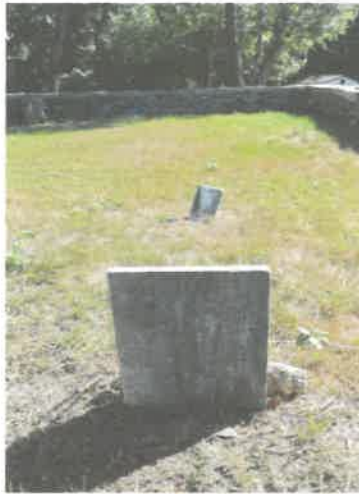
4 line inscription at base

White marble stone broken, and
re-set behind the broken base

Foot stone present, labeled
“B.S.”

Only foot stone in place at the
cemetery

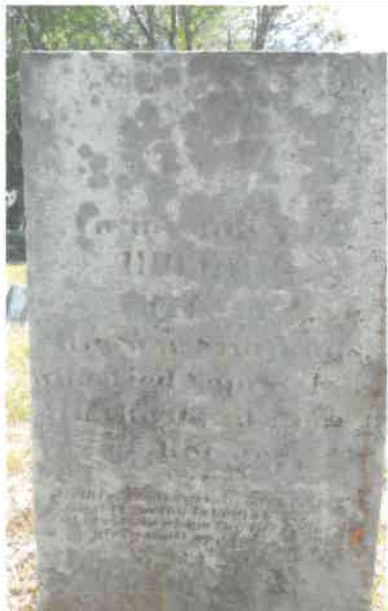
“In memory of
Huldah
wife of
Brown Simmons
who died Sept ##
in the ## year
of her age”

4 line inscription at the base

White marble, needs cleaning

Upright, stable
